Cement-Lock[®] Technology for Decontaminating Dredged Estuarine Sediments

PLANT OPERATIONS REPORT December 2003 – March 2005

**CEMENT-LOCK[®] TECHNOLOGY FOR
DECONTAMINATING DREDGED ESTUARINE SEDIMENTS
PHASE V – OPERATION OF THE CEMENT-LOCK
DEMONSTRATION FACILITY**

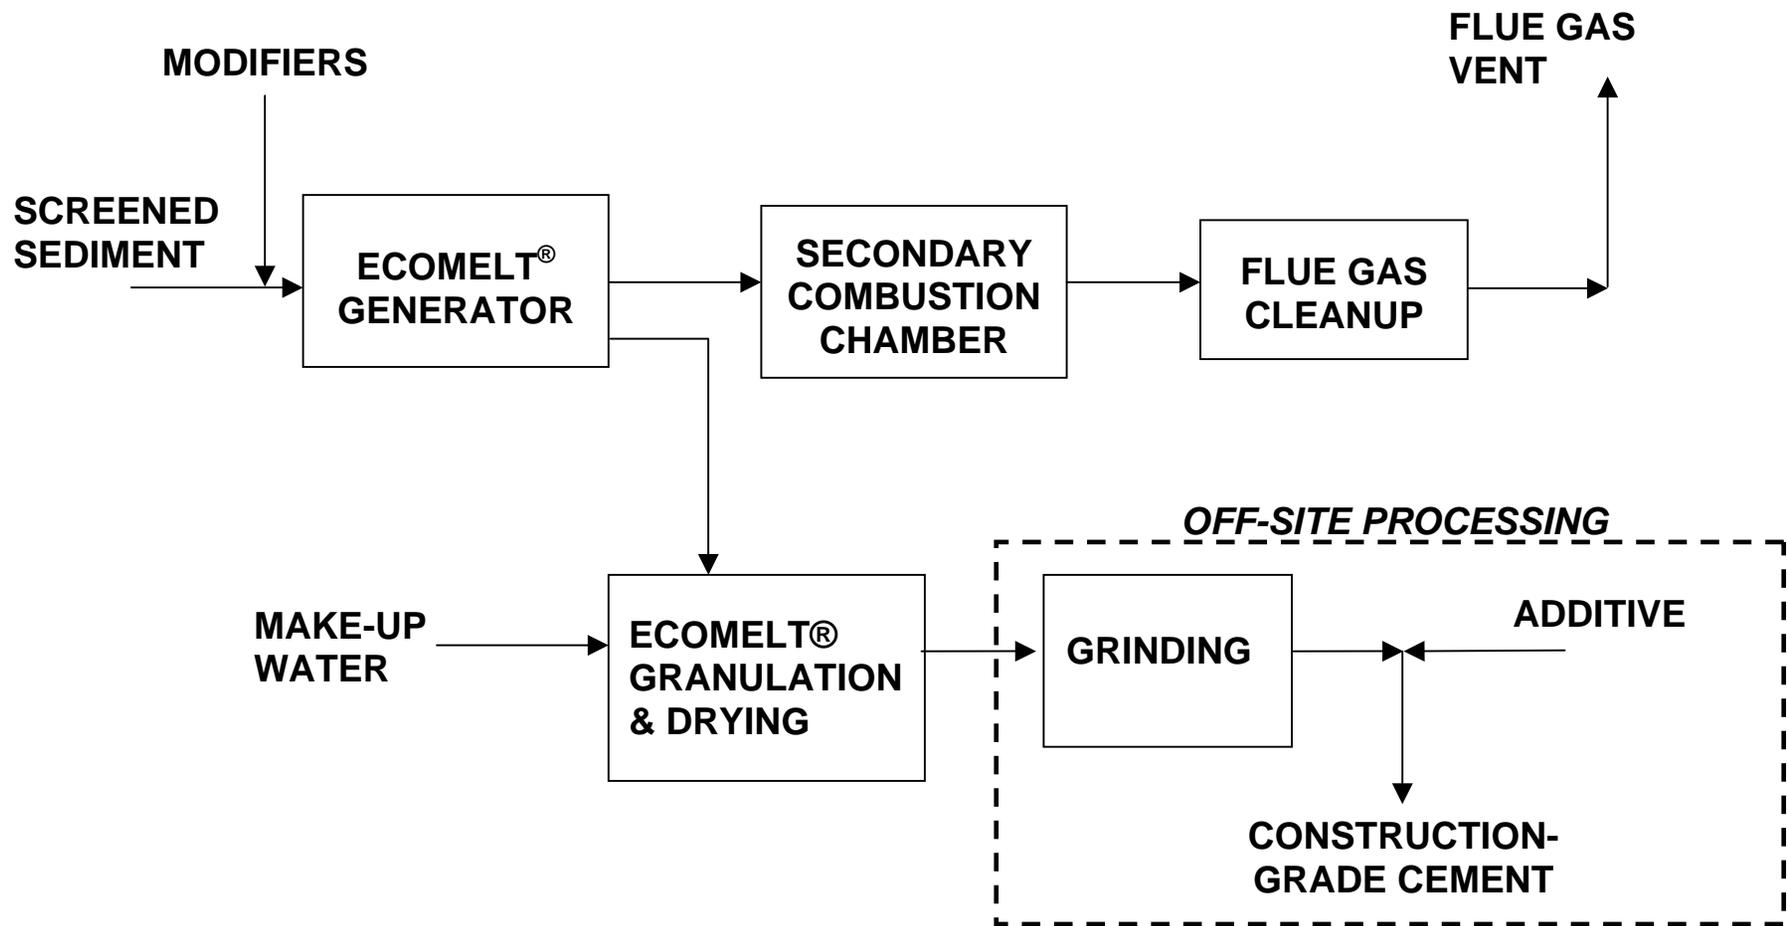
Figure 1. Process Flow Diagram for Cement-Lock Demonstration Plant

The Cement-Lock demonstration plant incorporates all of the major equipment components needed to demonstrate and characterize the process. The final steps in producing the Cement-Lock construction-grade cement, namely, grinding and blending the Ecomelt with ordinary Portland cement or another lime source will be done at an off-site facility. A simplified process flow diagram of the Cement-Lock demonstration facility is presented in Figure 1.

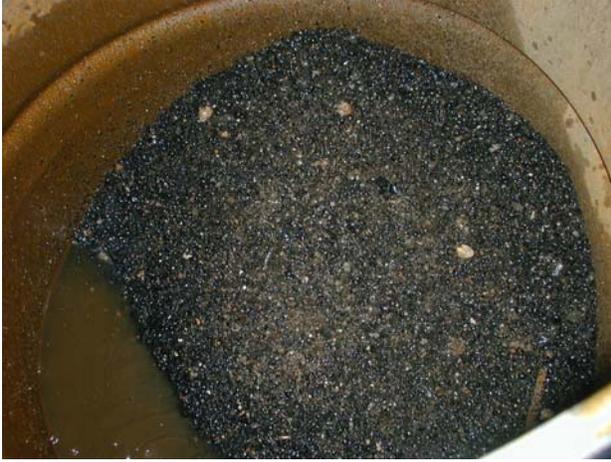
Figure 5. Initial Ecomelt Produced From Stratus Petroleum Sediment – Collected December 10, 2003.

At 3:10 p.m., the first sample of Ecomelt from Stratus Petroleum sediment was conveyed out of the granulator (Figure 5). Samples were taken for visual and microscopic examination. Under cross-polarized light, the desired non-crystalline (glassy) phases appear dark (Figure 6). The

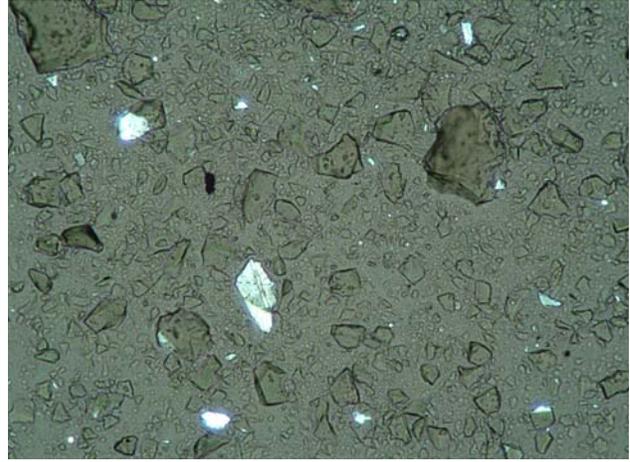
Figure 6. Ecomelt Viewed Under Cross-Polarized Light, the Desired Glassy (Dark) Phase Predominates. Bright Spots are Undesired Crystalline Phases.

undesired crystalline phases appear as bright spots. The estimated desired glassy composition of the Ecomelt sample was over 90 percent. Manual feeding was halted just after 3:00 p.m. as the operators changed shifts. Feeding was resumed at 4:00 p.m.

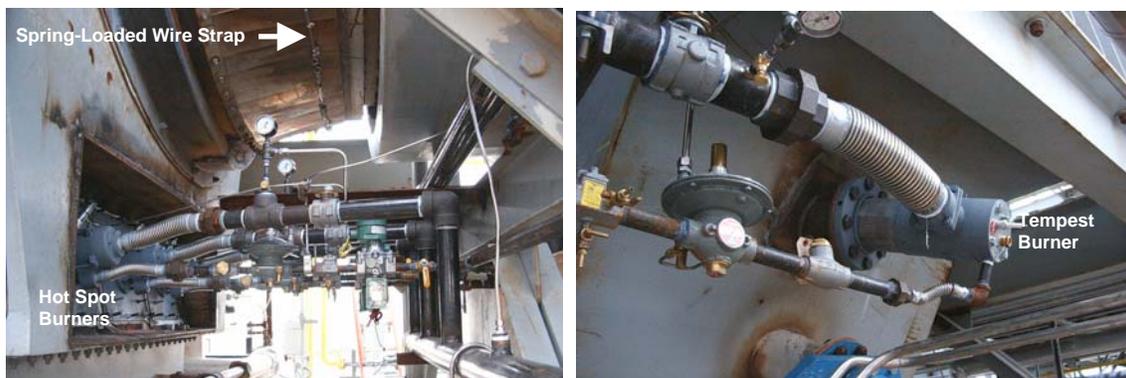
The air seal was improved by the simple addition of a wire strap wrapped circumferentially around the individual steel leaves connected with a spring (photograph above left). The spring keeps the wire taut and the leaves from flapping.

The new nozzle on the west side of the drop-out box enables the concentrations of O₂ and CO of the flue gases exiting the rotary kiln to be measured to facilitate the settings of natural gas and air inputs and to improve combustion efficiency and reduce excess air (which saves fuel).

These modifications and retrofits will minimize the heat loss from the kiln discharge and provide additional thermal input so that the slag discharged from the kiln can be kept in a fluid molten state. The photograph (below left) shows the three new North American Manufacturing Co. Hot Spot burners installed at the drop-out box and connected to the natural gas and air supplies. The photograph (below right) shows the high-velocity Tempest burner installed on the north wall of the drop-out box (a second burner is installed on the south wall).

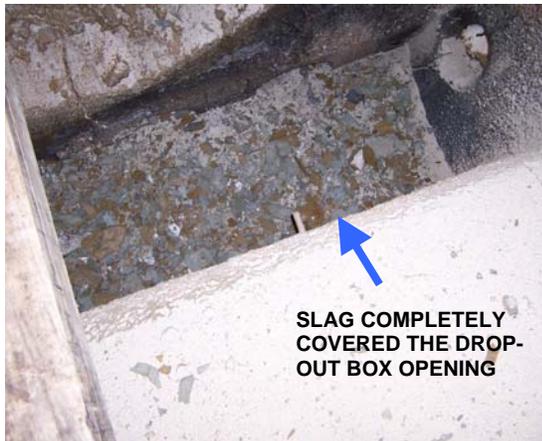
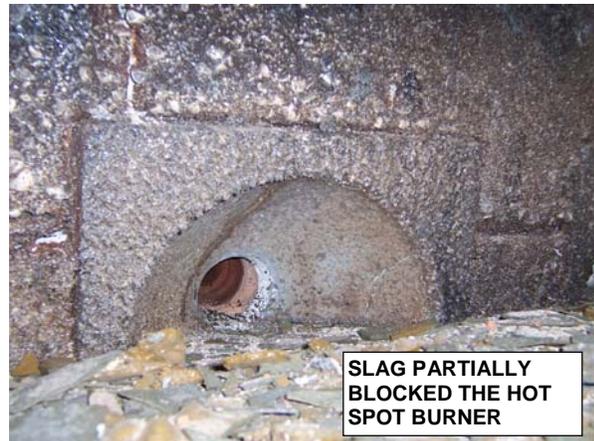
On July 20, the system had cooled sufficiently for personnel to enter and make a photographic record of the slag accumulation in the drop-out box. The photo (above left) shows that the top level of the slag was uniformly flat. It had completely covered over the granulator opening just below the new Hot Spot melt burners. The photo (above right) shows slag had begun to fill the nozzle of the Hot Spot burner under the new refractory “lip”. As mentioned above, the drop-out box had been heated by the melt burners overnight at about 2600°F and the slag had flowed to a uniformly flat level. Thin layers of slag also flaked from the walls and kiln as shown in the photo.

Operating staff entered the drop-out box with a jackhammer and began chipping away at the slag. Within two hours, the slag had been completely broken up. Shards of slag were removed from the granulator through the sample port at the entrance to the C-205 conveyor. Later, to facilitate removal of any oversize slag in future tests, FMW installed an access/clean out port on the upper end of the C-203 conveyor. Figure 9 shows the time-temperature history of Test No. 2 of the Cement-Lock demo plant from July 16 to 17, 2004 with retrofits and enhancements in

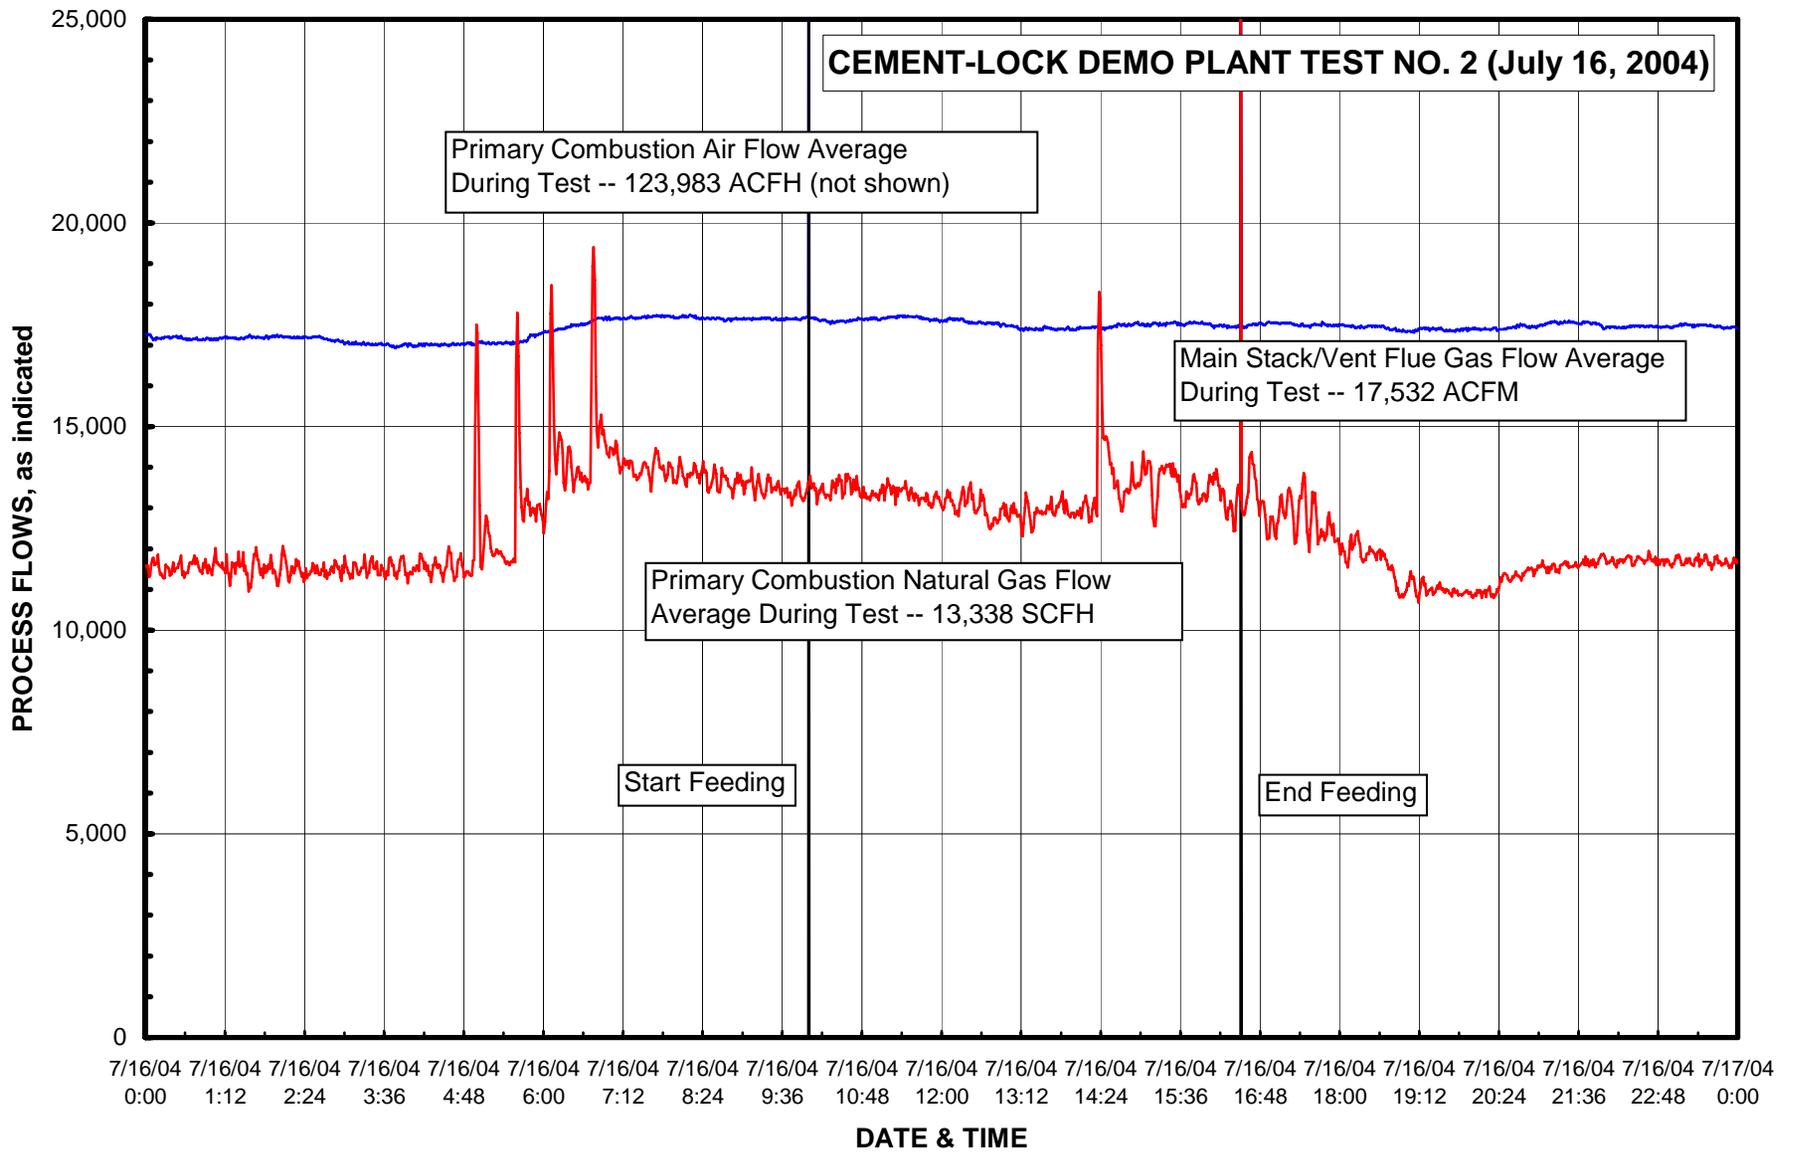
Figure 10. Major Process Flows Recorded During Cement-Lock Demo Plant Test No. 2 With Retrofits and Enhancements (July 16-17, 2004)

place. Major process flows from the test are shown in Figure 10. The primary combustion air to the rotary kiln averaged 123,983 ACFH. The average flow of natural gas to the rotary kiln was 13.3 million Btu/hour. The flow of flue gases from the main vent stack averaged 17,532 ACFM during the test.

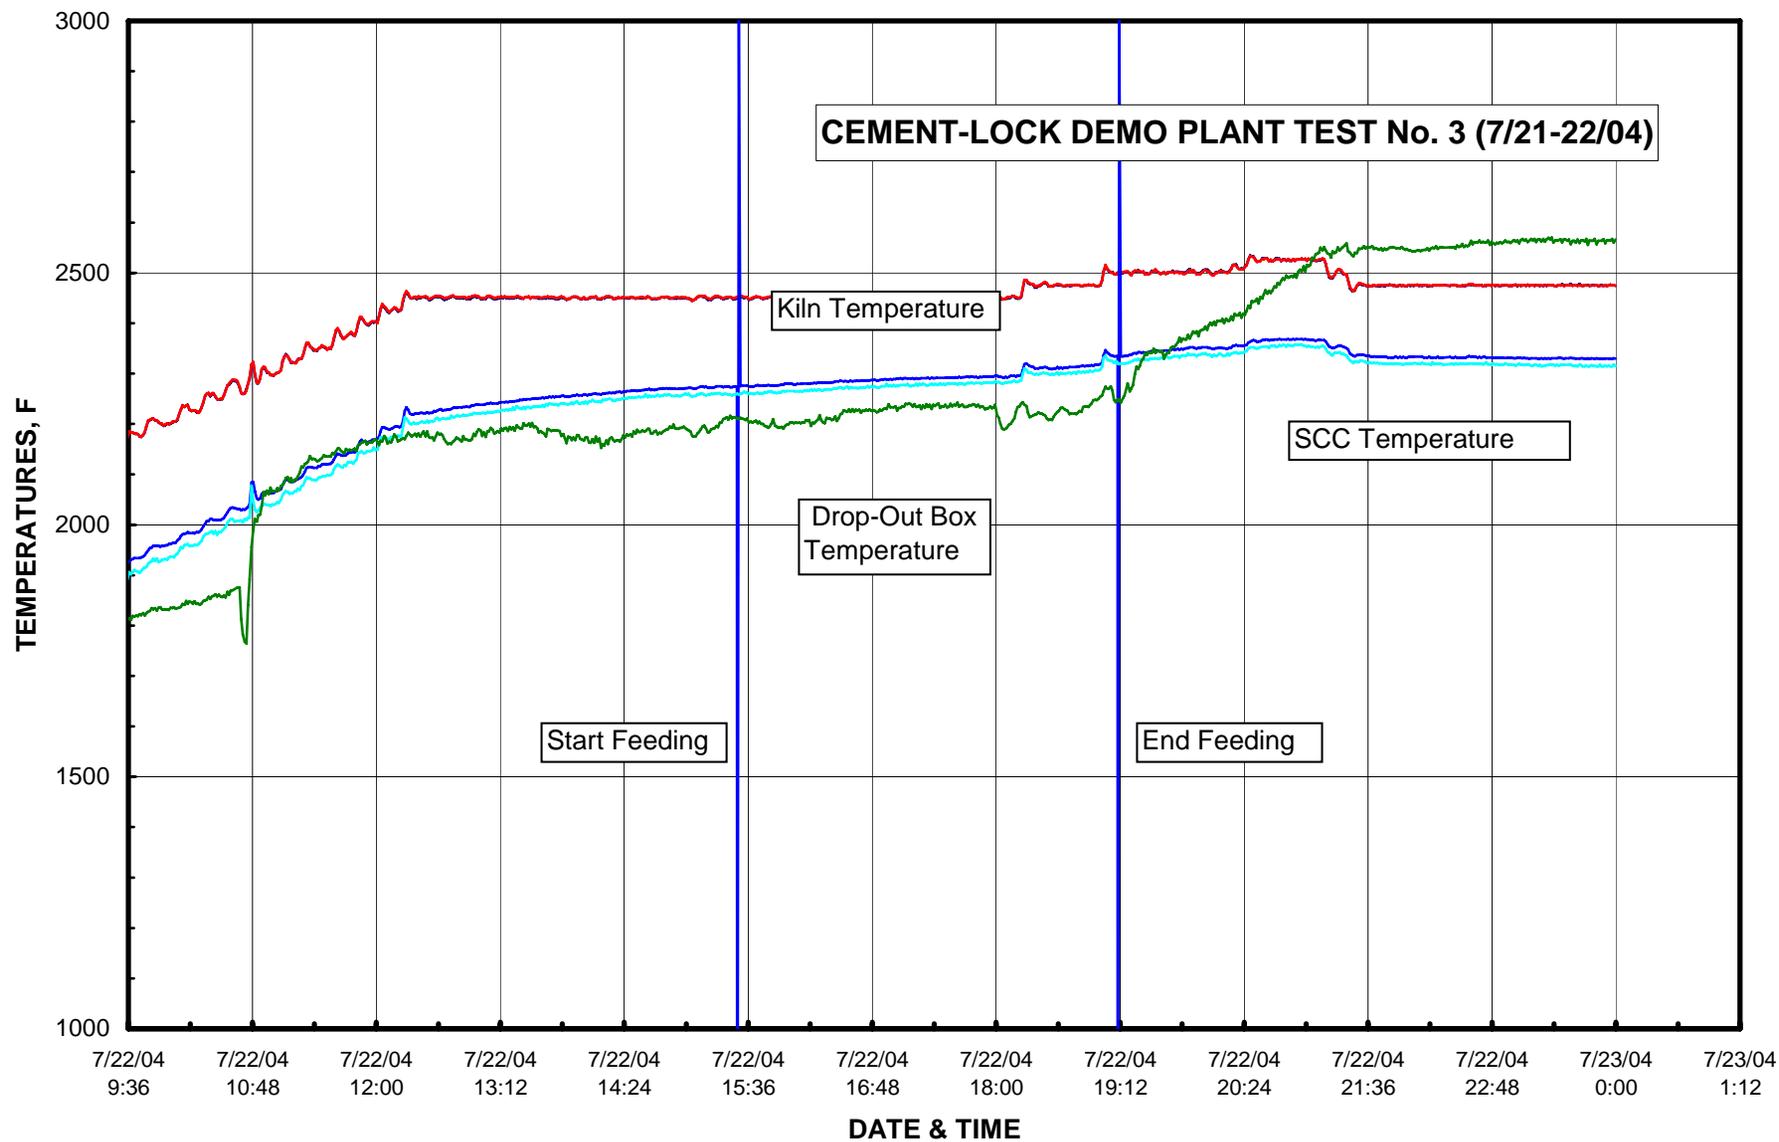
Figure 11. Time-Temperature History of Cement-Lock Demo Plant Test No. 3 With Retrofits and Enhancements (July 21-22, 2004)

Slag “rain” was also observed to fall from the ceiling of the kiln as it rotated during this test. Figure 11 shows the time-temperature history of Test No. 3 of the Cement-Lock demo plant from

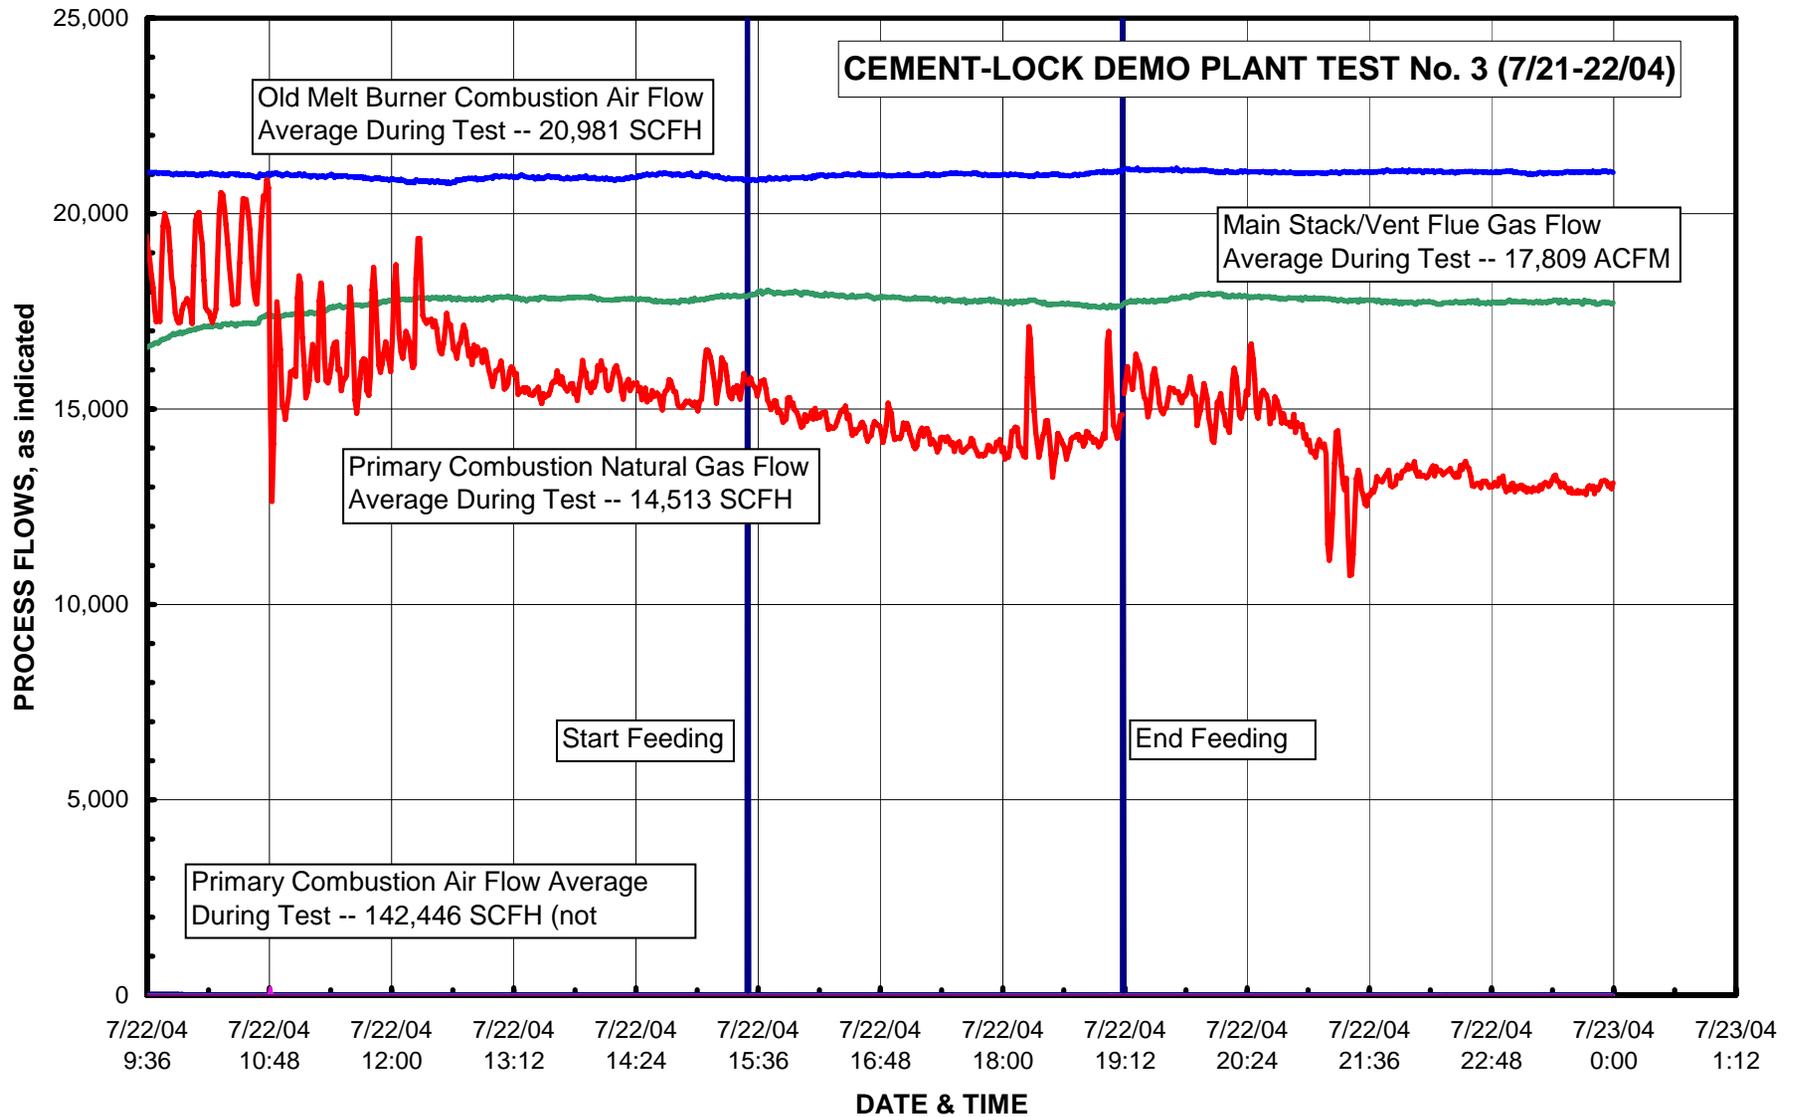
Figure 12. Major Process Flows Recorded During Cement-Lock Demo Plant Test No. 3 With Retrofits and Enhancements (July 21-22, 2004)

July 21 to 22, 2004 with retrofits and enhancements in place. Major process flows are presented in Figure 12. The primary combustion air to the rotary kiln averaged 142,446 ACFH. The average flow of natural gas to the rotary kiln was 14.5 million Btu/hour. The flow of flue gases from the main vent stack averaged 17,532 ACFM during the test.

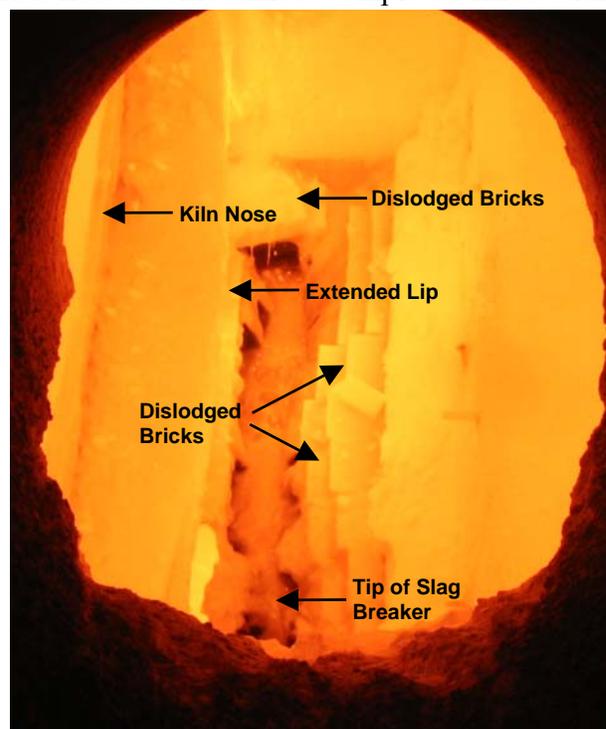
Figure 14. View of Slag Accumulated on Bricks and Slag Breaker After Test No. 5 (lighter colors are relatively hotter than darker colors)

The molten slag flowing over the bricks at the throat of the drop-out box appeared to be much more viscous than the molten slag flowing in

the kiln and over the nose and lip. Observations also confirmed that the more viscous molten slag over and down from the bricks precipitated the slag accumulation and the eventual plug up.

Reconsider effectiveness of slag breakers: As the slag cools, its viscosity increases significantly. The slag has the consistency of taffy and does not shatter upon impact. The slag breakers must be operated almost continuously, otherwise they will become ineffective as slag freezes on top of

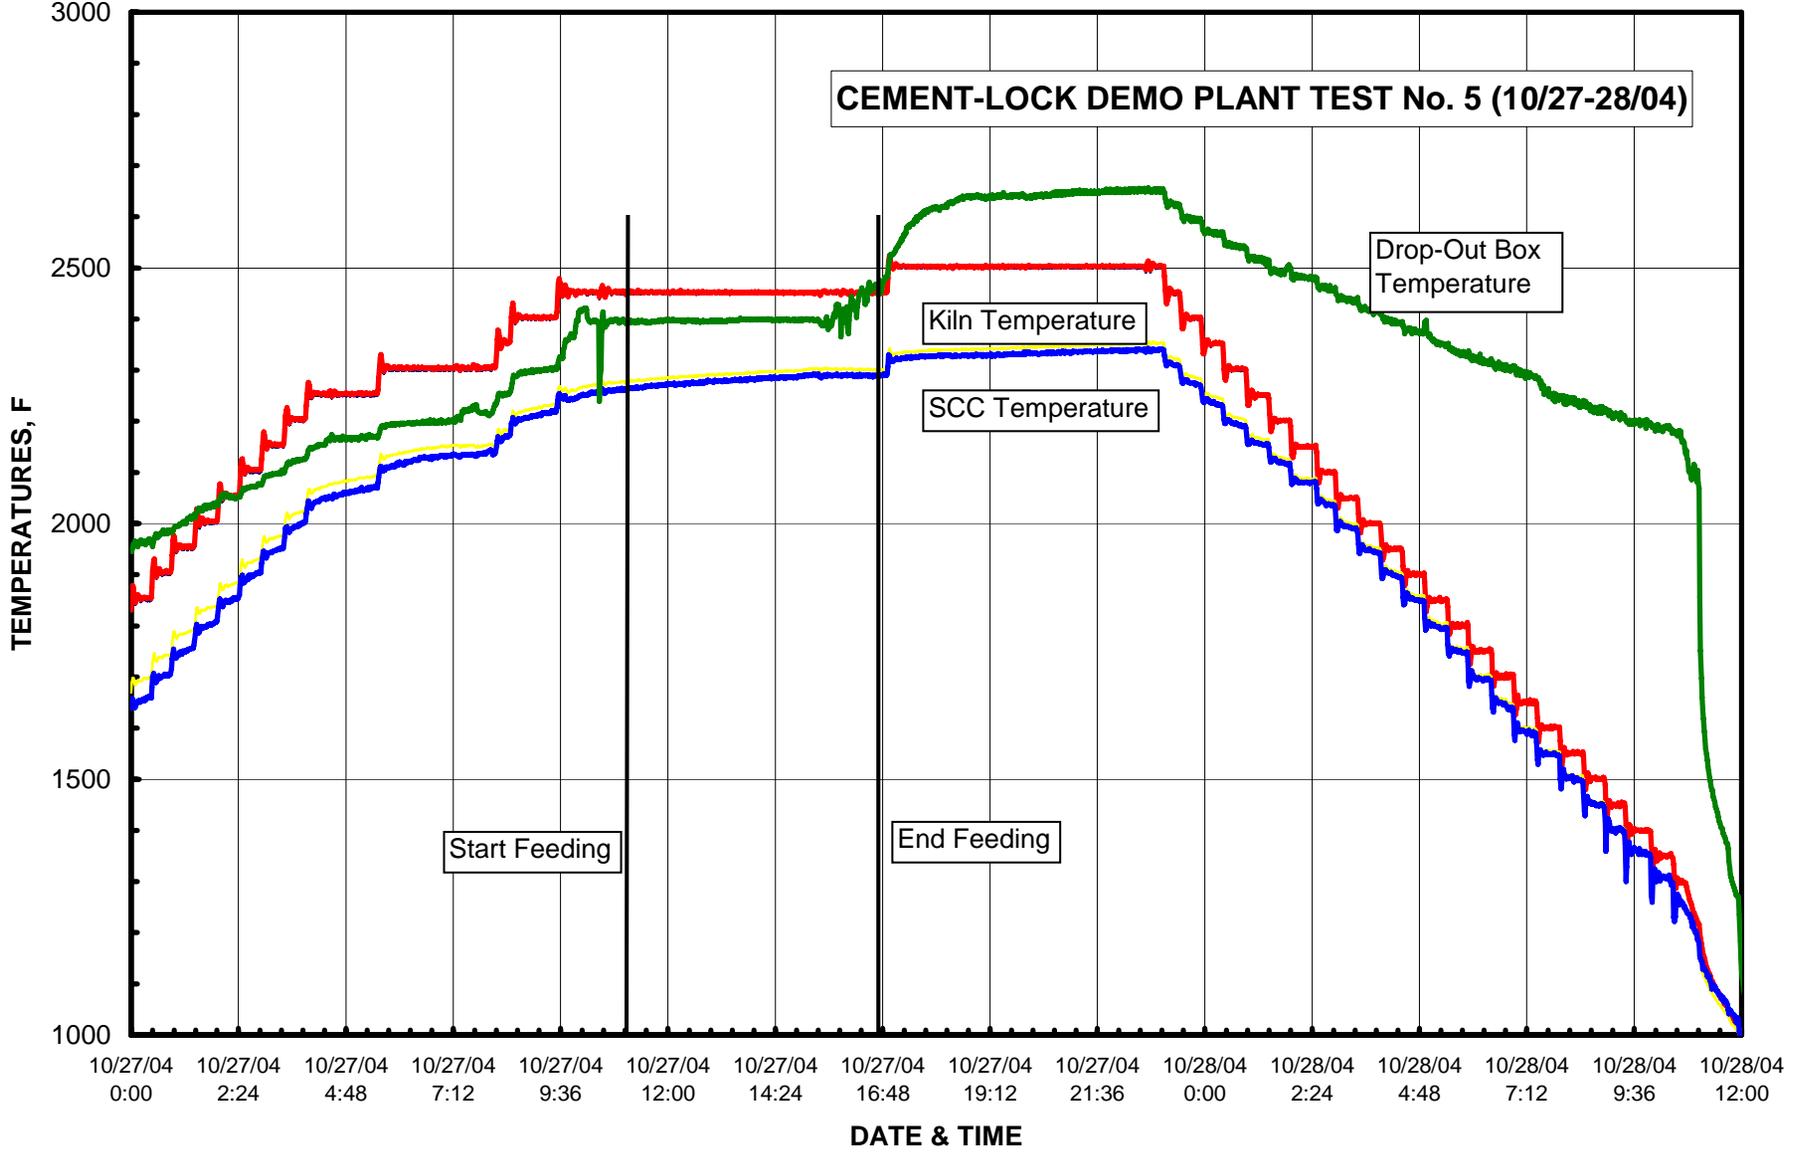
Figure 15. Time-Temperature History of Cement-Lock Demo Plant Test No. 5 (October 27-28, 2004)

A total of 849 pounds of Ecomelt was produced during the test. The time-temperature history of this test is presented in Figure 15. Major process flows from the test are presented in Figure 16. The primary combustion air to the rotary kiln averaged 143,141 ACFH. The average flow of natural gas to the rotary kiln was 14.2 million Btu/hour. The flow of flue gases from the main vent stack averaged 17,311 ACFM during the test.

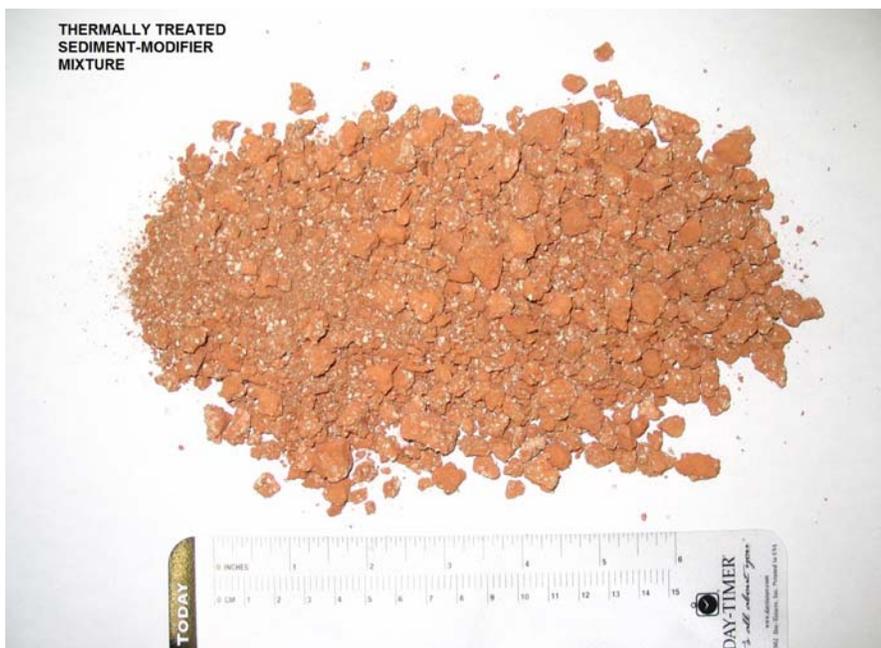
Figure 17. Photo of EcoAggMat Produced in Laboratory-Scale Furnace

Upon breaking, the exposed fresh surface of the clumps has the same color as the external surface indicating that the treatment was uniform.

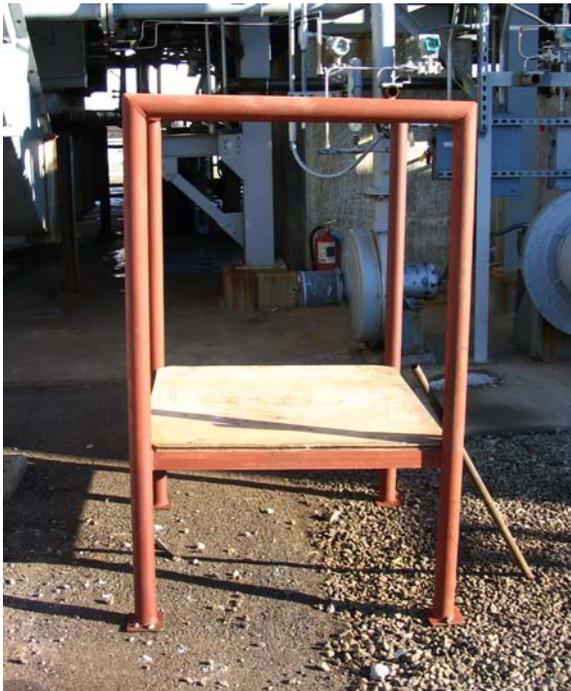
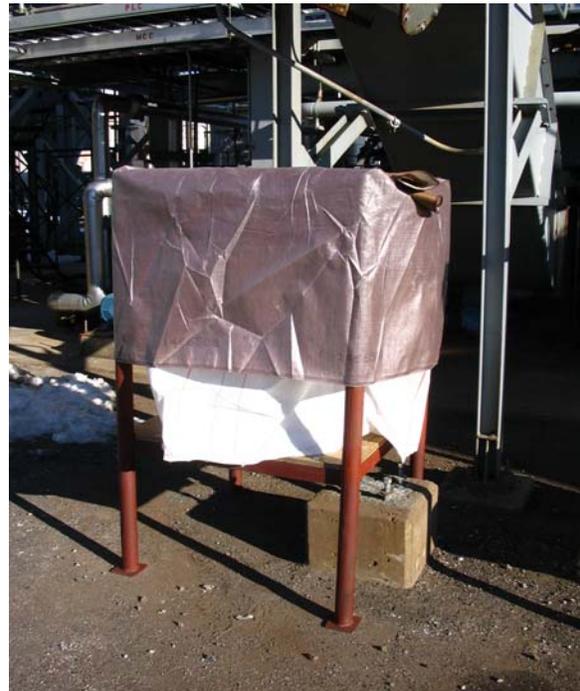
EcoAggMat Collection: We designed and FMW fabricated two stands to collect EcoAggMat as it was discharged from the inclined drag conveyor (C-203) discharge chute. Having two stands

enabled us to recycle the first stand while the other was collecting EcoAggMat. When the Super sack was filled, the drag conveyor would be momentarily shut down. The photo above left shows one stand as built. The photo above right shows the stand with Super sack in place in position under the C-203 discharge chute. The Super sacks were 39 inches by 39 inches by 36 inches tall with duffle top openings. Each Super sack had a plastic liner to prevent any excess moisture from leaking out of the Super sack onto the ground. This arrangement worked very well during the non-slagging campaign.

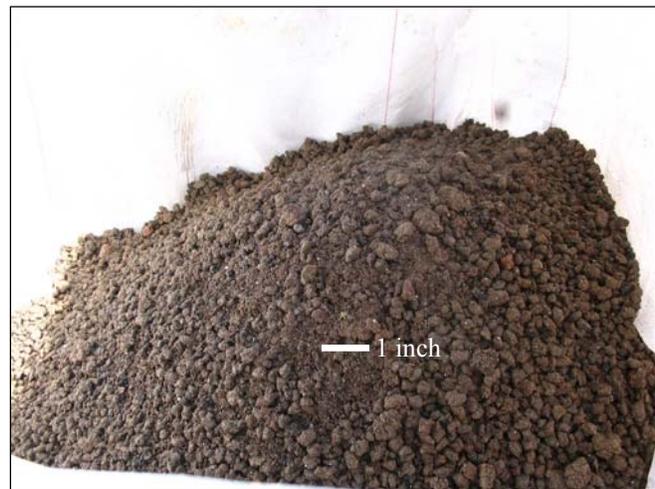
Thermally treated material flowing from the kiln was generally in the shape of small irregularly shaped particles, spheres, or oblate spheroids. The size ranged from sand to about 1 inch in size (Photo at right shows EcoAggMat collected in a Super Sack).

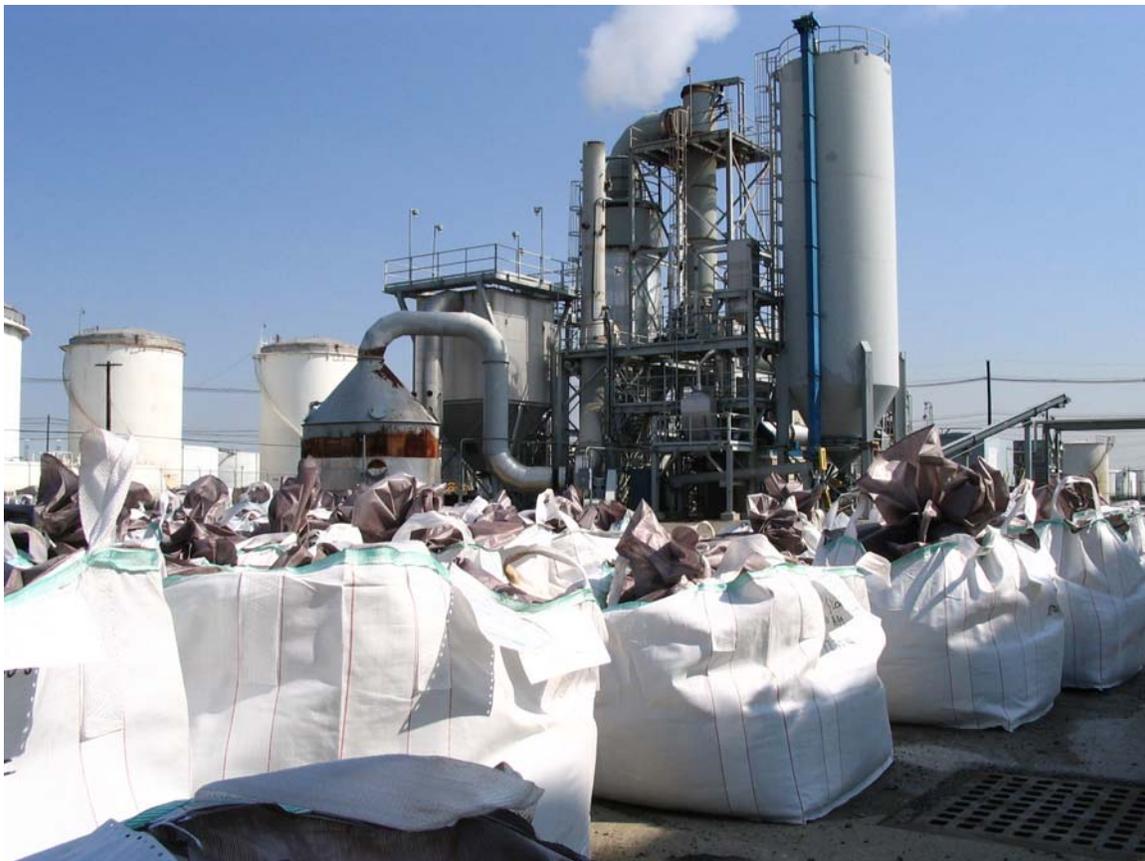
Overall, we estimate that about 80 yd³ of sediment-modifier mixture was processed through the Cement-Lock demo plant system from March 5 through 21, 2005. The EcoAggMat was collected in 107 Super sacks (see photo below).
